**IV. IMMEDIATE/HIGH PRIORITY RECOMMENDATIONS AUDITED**

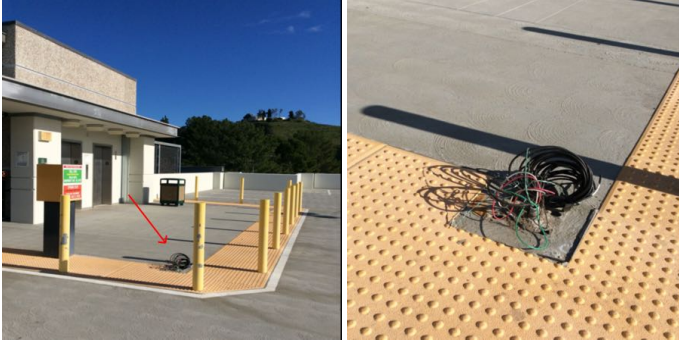
**Location:** Ventura County Community College Dist. - MOORPARK COMMUNITY COLLEGE - P-Lot PS (Parking Structure) Top Level Near Elevators

**Priority:** High

**Description:** The cables from a removed call box were left behind and may present a trip hazard and/or electrical hazard. Consider removing the cables to reduce the hazard. Note: This was reported to the Maintenance Department. As a temporary measure, a traffic cone was placed on top of the cables.

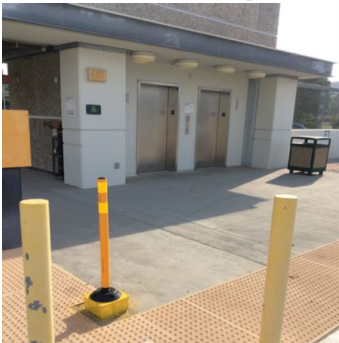
**Status:** Closed

**Close Note:** On each level, the cables were covered. A yellow plastic post was installed for greater visibility.

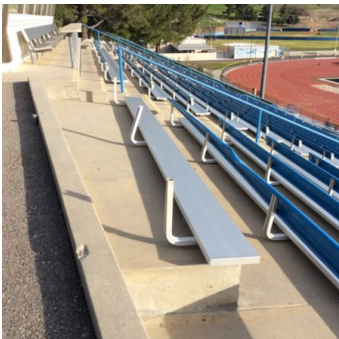
**Location:** Ventura County Community College Dist. - MOORPARK COMMUNITY COLLEGE - Stadium Home Side Back Row Bleachers

**Priority:** High

**Description:** Near the top row of the stadium home bleachers, a back rest is missing, leaving behind two metal posts. The metal posts may present a hazard to visitors. Consider installing a back rest or remove the metal posts.

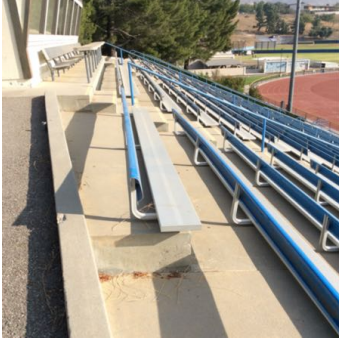
**Status:** Closed

**Close Note:** A back rest installed.

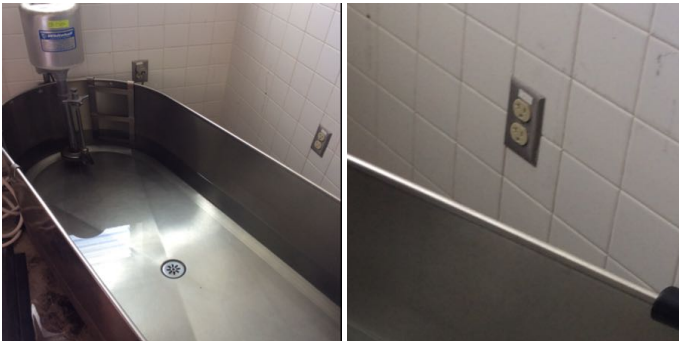
**Location:** Ventura County Community College Dist. - VENTURA COMMUNITY COLLEGE - C-1 Bldg. Athletics Training Room

**Priority:** High

**Description:** Electric outlets that are located within 6' of sinks should be connected to a ground fault circuit interrupter (GFCI). Consider installing outlets higher than the height of the bath tubs.

**Action Notes:** At the time of the audit, we were unable to access this room. The room was tested for hazardous gases due to earlier staff complaint. Martin Navarro is working with the electrician to install a GFCI for the electrical outlet.
