PROPERTY & LIABILITY ASSESSMENT AUDIT

VENTURA COUNTY COMMUNITY COLLEGE DISTRICT

RE: SWACC PROPERTY & LIABILITY ASSESSMENT FOLLOW-UP AUDIT

Enclosed is the report for the SWACC Property & Liability Inspection Follow-up Audit conducted for the District on September 18, 2020. The purpose of the Follow-up Audit is to review the progress made in addressing the priority recommendations listed in the SWACC Property & Liability Inspection conducted on January 27-31, 2020. The Follow-up Audit was conducted in accordance with the SWACC safety inspection policy.

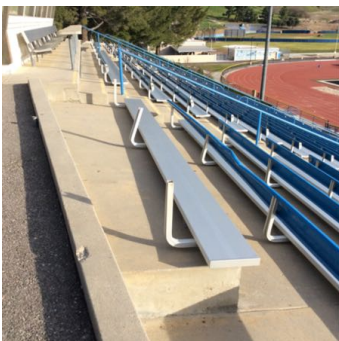
Location: Ventura County Community College Dist. - MOORPARK COMMUNITY COLLEGE - Stadium Home Side Back Row Bleachers

Description: Near the top row of the stadium home bleachers, a back rest is missing, leaving behind two metal posts. The metal posts may present a hazard to visitors. Consider installing a back rest or remove the metal posts.

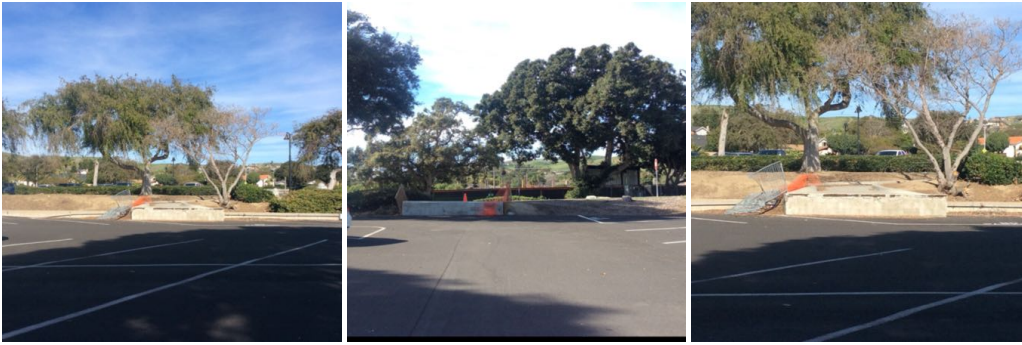
Location: Ventura County Community College Dist. - VENTURA COMMUNITY COLLEGE - Parking Lot V

Description: There is potential for an individual to fall off these platforms. Edge protection (i.e., guardrails) should be provided to reduce this fall hazard.

Action Notes: Guardrails were installed but were vandalized. Apparently, there are plans to put classroom trailers in this parking lot. These platforms will be used as access to the trailers. Until this happens, consider installing fencing around the platform rather than on the platform. Posting warning signs is recommended.

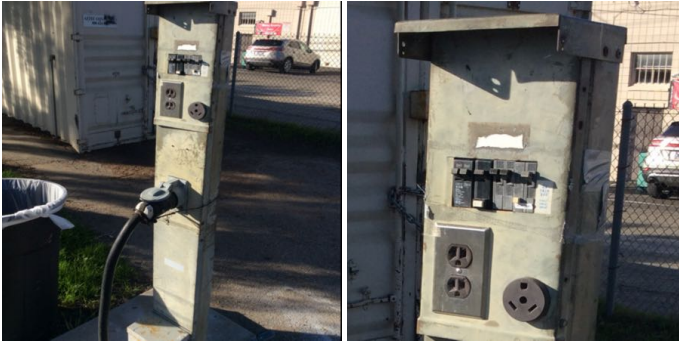
Location: Ventura County Community College Dist. - VENTURA COMMUNITY COLLEGE - Tri-Valley Girls Softball Field (for Lease)

Description: The electrical panel cover is missing and should be replaced. In general, electrical equipment should be secured from public access. To prevent vandalism, consider installing a secure enclosure for the electrical panel.

Action Notes: Martin Navarro is working on this. It is recommended to install an enclosure to prevent any type of vandalism to the electrical equipment.

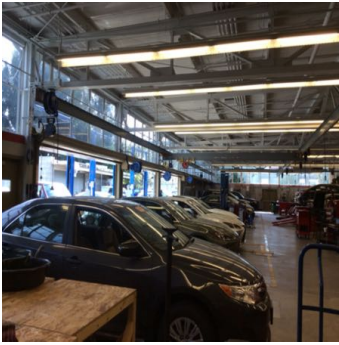
Location: Ventura County Community College Dist. - VENTURA COMMUNITY COLLEGE - WAM Bldg. Auto Technology Lab

Description: There are no local exhaust ventilation hoses in this shop. The instructors stated that the garage doors are open while vehicles are running; however, local exhaust ventilation should still be provided. Consider installing hoses that can be fully extended to each vehicle workstation. Use of CO monitors is also recommended.

Close Note: This item is in the Department's Program Review for approval. The Automotive Instructors put in the request for ventilation and shelters for their lifts every year. For now, air ducting is being used to vent car exhaust through the garage doors. It is still recommended to install CO monitors for each workstation.

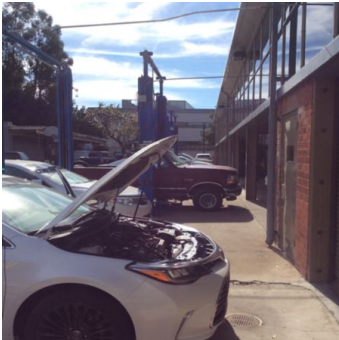
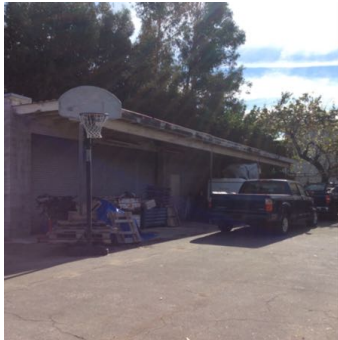
Location: Ventura County Community College Dist. - VENTURA COMMUNITY COLLEGE - WAM Bldg. Auto Technology Yard

Description: 1. Installing a lift outside increases the likelihood of property damage and/or failure caused by the natural elements. Consider providing a protective shelter for the lifts and the power units. 2. During inclement weather conditions, the metal roofing of the storage building blows upwards and provides less protection for the car engines stored inside. Consider repairing the roof or replacing it.

Close Note: This item is in the Department's Program Review for approval. The Automotive Instructors put in the request for ventilation and shelters for their lifts every year.
