**RE: SWACC PROPERTY & LIABILITY ASSESSMENT FOLLOW-UP AUDIT**

On September 18, 2020, Keenan & Associates conducted a Property & Liability Inspection Follow-up Audit for the Ventura County Community College District located in Ventura County, California. The purpose of the Inspection Follow-up Audit is to review all of the priority recommendations listed in the previous SWACC Property & Liability Inspection and to note any progress made in addressing or correcting those priority issues. Iris Penales, Consultant, conducted the inspection and Clare Brooks, Project Coordinator, processed the Follow-up Audit report.

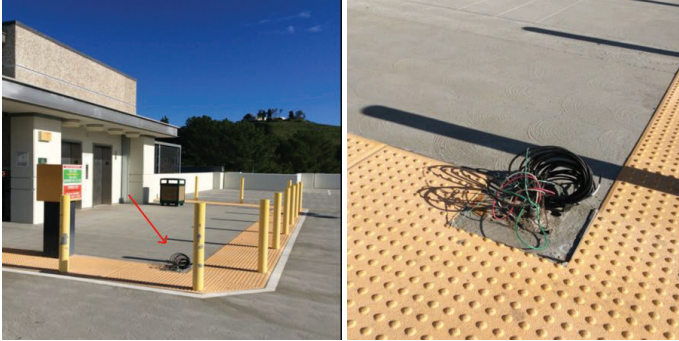
**Location:** Ventura County Community College Dist. - MOORPARK COMMUNITY COLLEGE - P-Lot PS (Parking Structure) Top Level Near Elevators

**Description:** The cables from a removed call box were left behind and may present a trip hazard and/or electrical hazard. Consider removing the cables to reduce the hazard. Note: This was reported to the Maintenance Department. As a temporary measure, a traffic cone was placed on top of the cables.

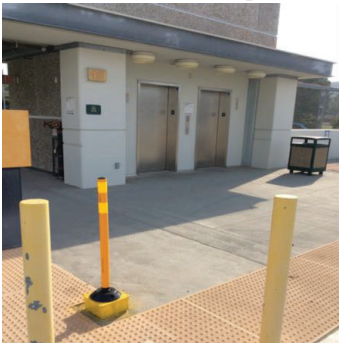
**Close Note:** On each level, the cables were covered. A yellow plastic post was installed for greater visibility.

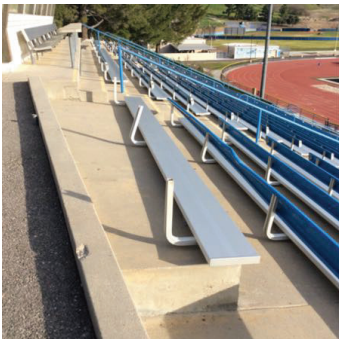
**Location:** Ventura County Community College Dist. - MOORPARK COMMUNITY COLLEGE - Stadium Home Side Back Row Bleachers

**Description:** Near the top row of the stadium home bleachers, a back rest is missing, leaving behind two metal posts. The metal posts may present a hazard to visitors. Consider installing a back rest or remove the metal posts.

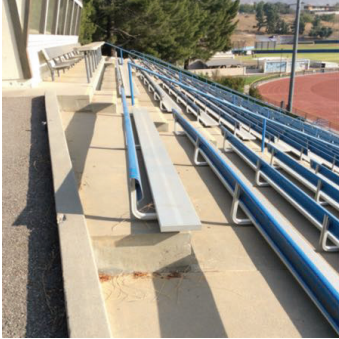
**Close Note:** A back rest installed.

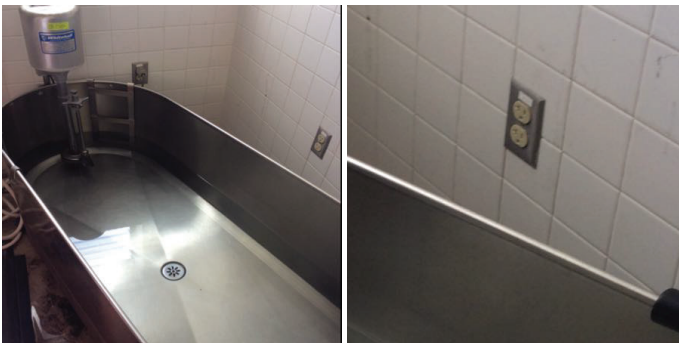
**Location:** Ventura County Community College Dist. - VENTURA COMMUNITY COLLEGE - C-1 Bldg. Athletics Training Room

**Description:** Electric outlets that are located within 6' of sinks should be connected to a ground fault circuit interrupter (GFCI). Consider installing outlets higher than the height of the bath tubs.

**Action Notes:** At the time of the audit, we were unable to access this room. The room was tested for hazardous gases due to earlier staff complaint. Martin Navarro is working with the electrician to install a GFCI for the electrical outlet.
